NASA TM X-64086

TEST OF LOX COMPATIBILITY FOR ASPHALT
AND CONCRETE RUNWAY MATERIALS

John F. Kennedy Space Center
Kennedy Space Center, Fla. 32899

December 1973

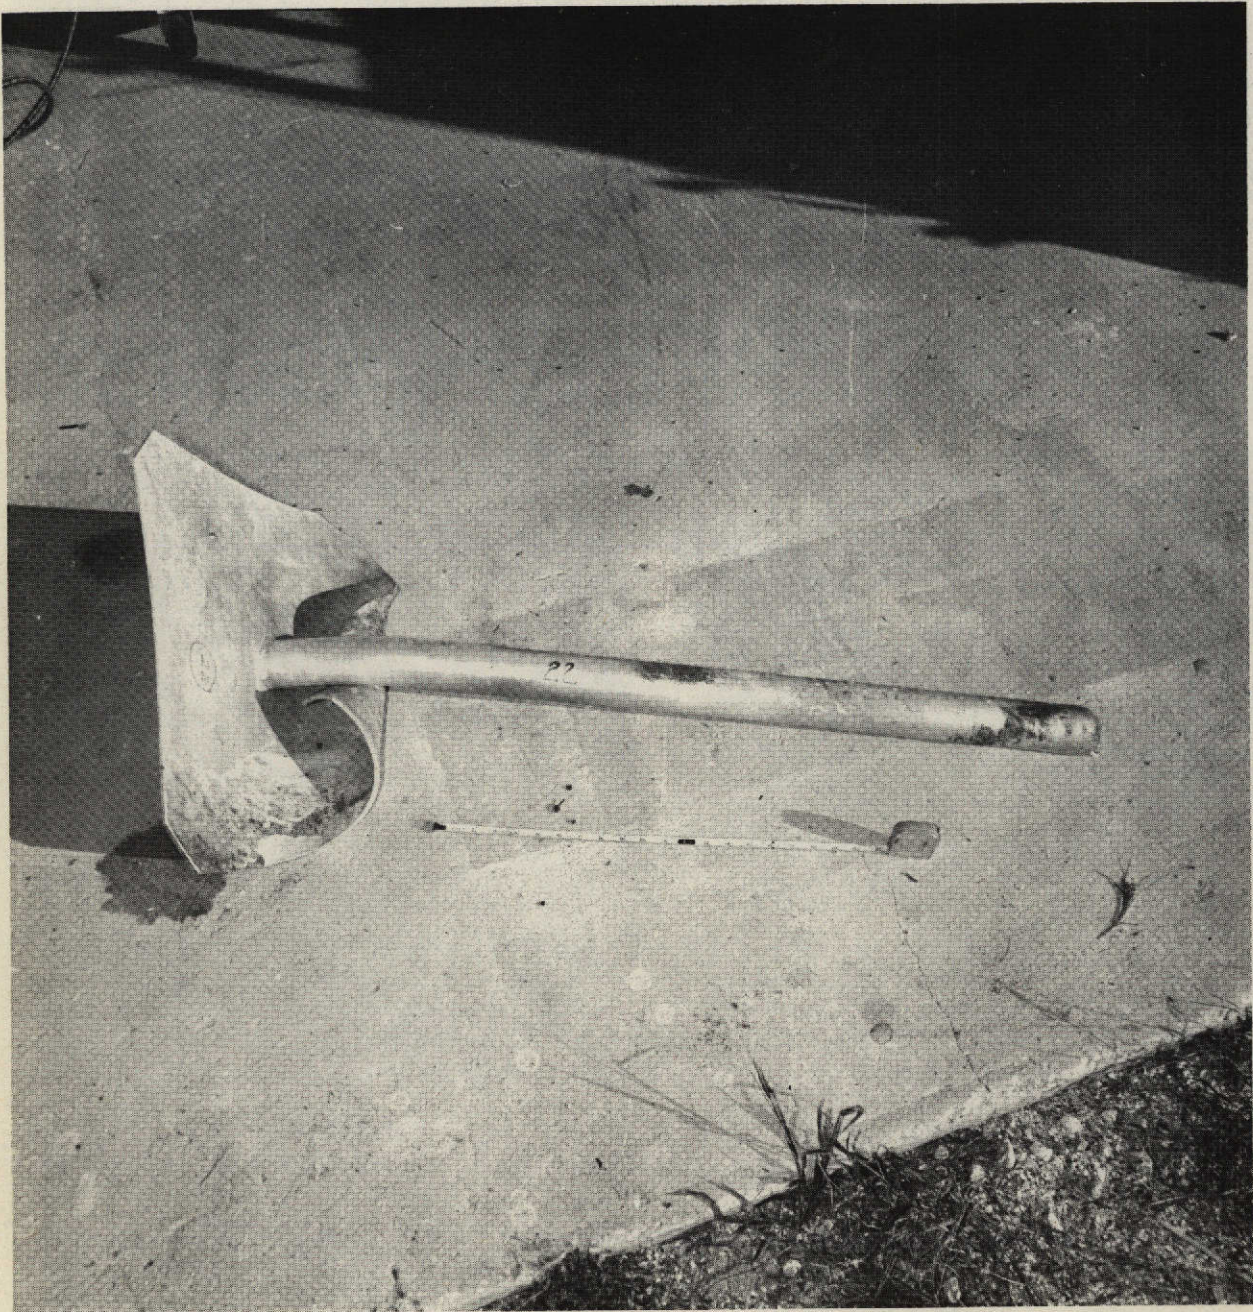
Figure 16. Leg, Fragment 22.

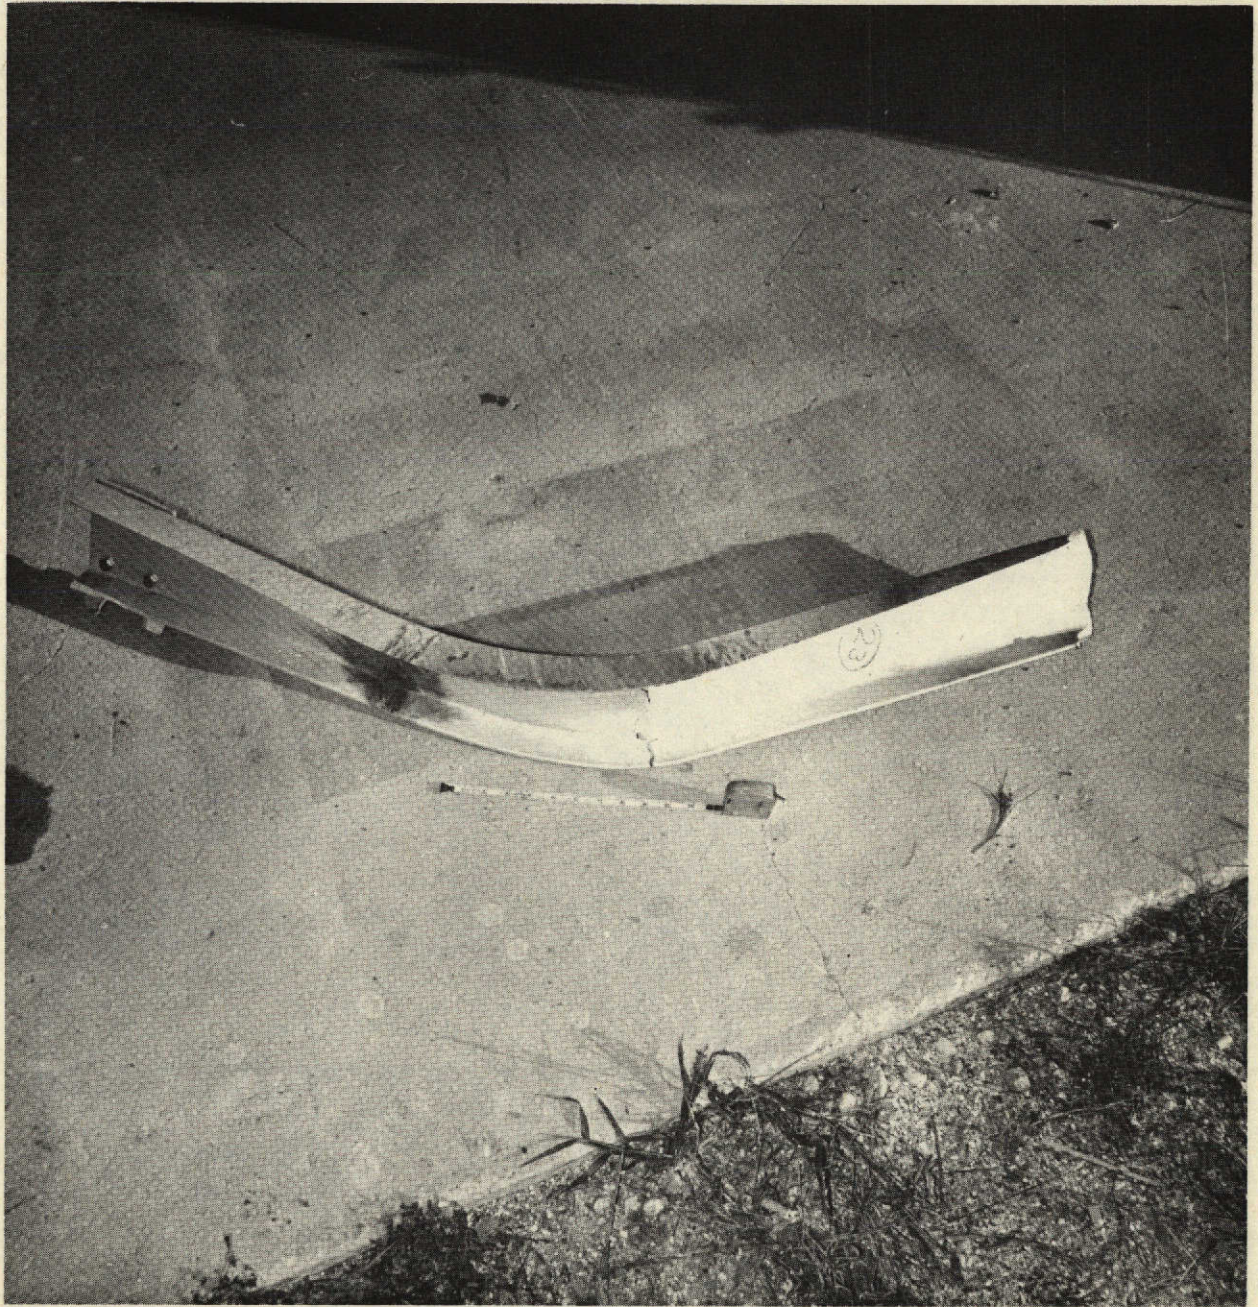
Figure 17. Channel, Fragment 23.

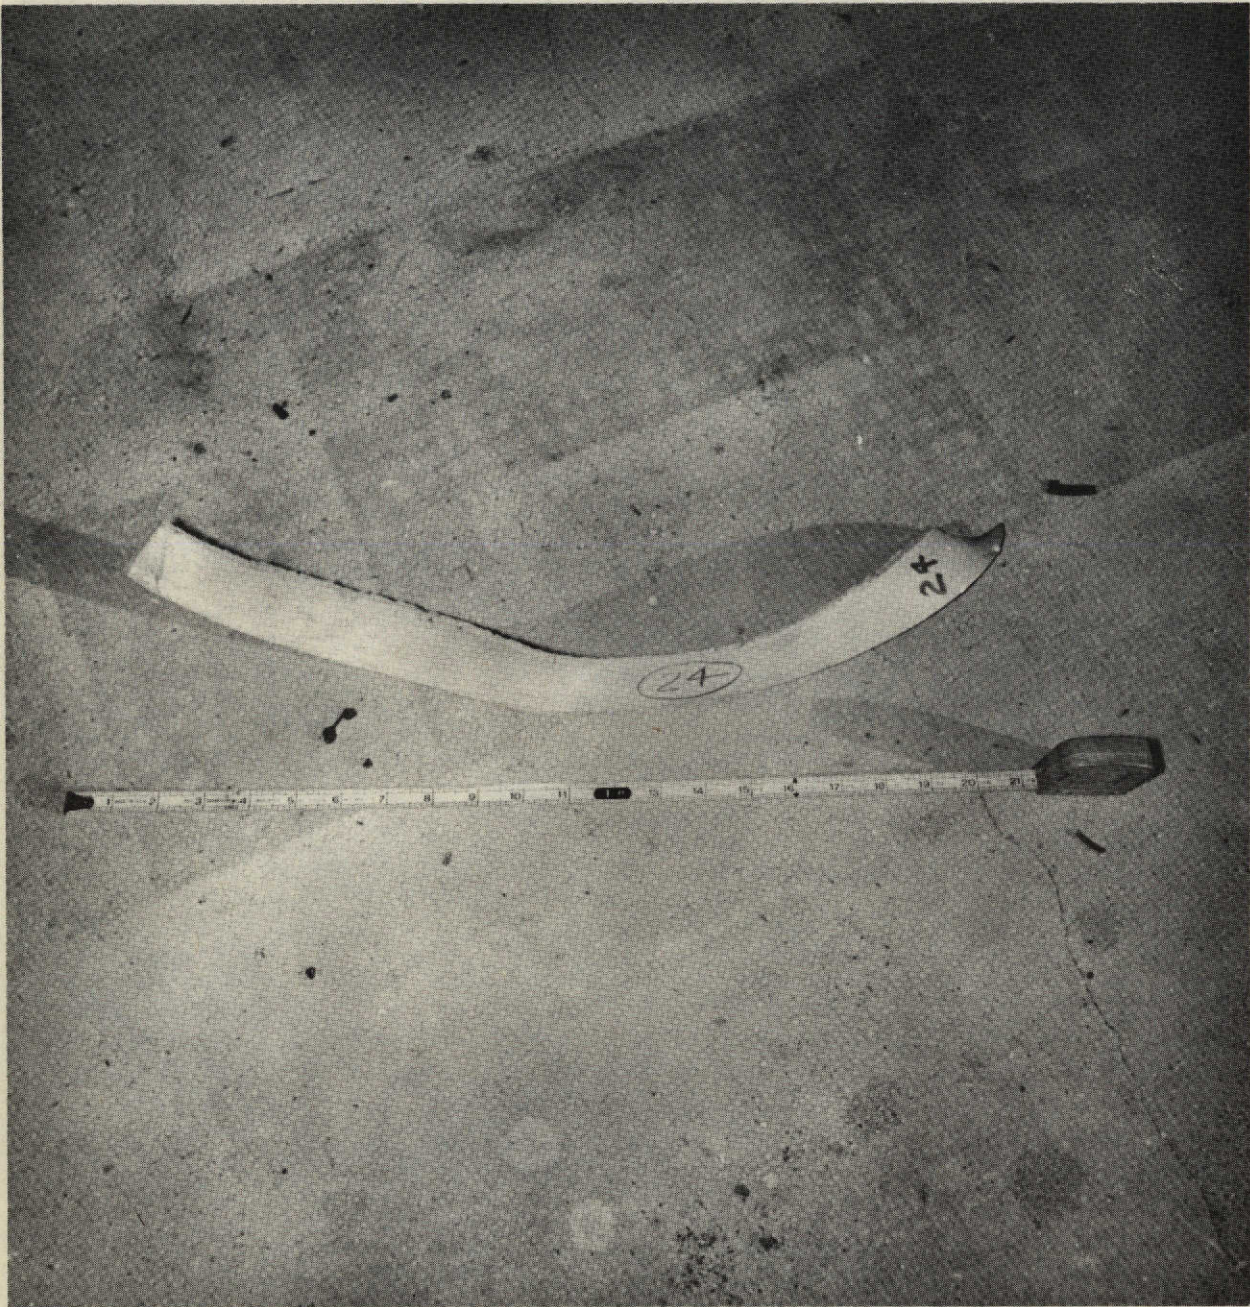
Figure 18. Aluminum Fragment 24.

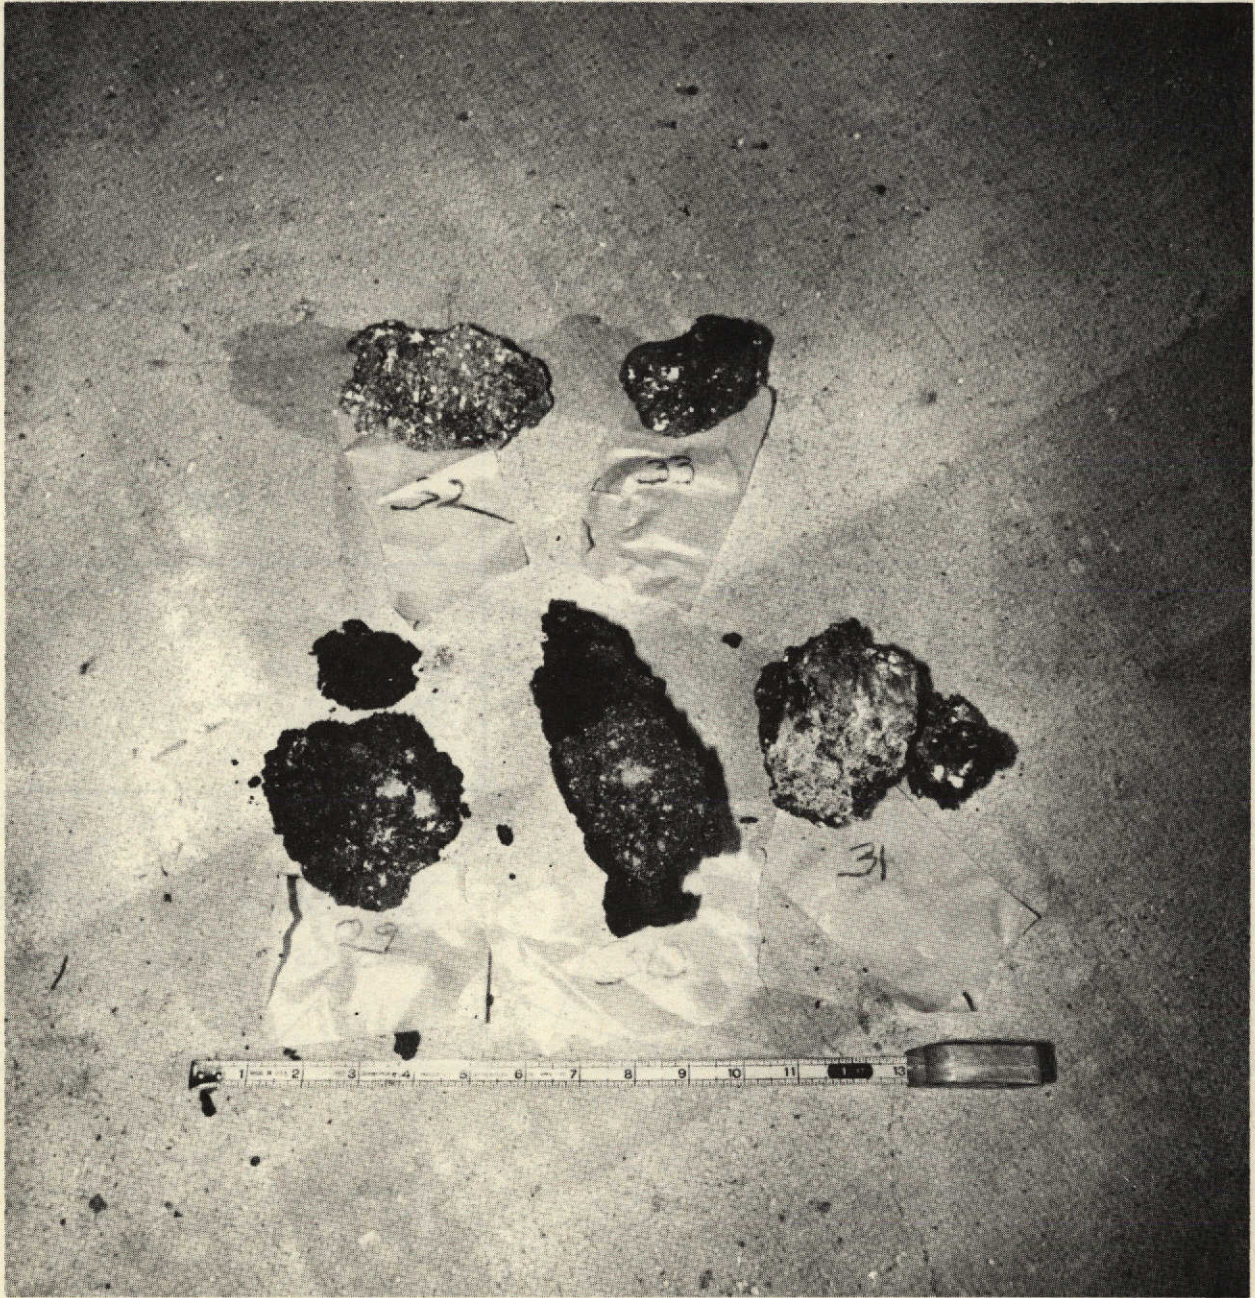
Figure 19. Asphalt Fragments.

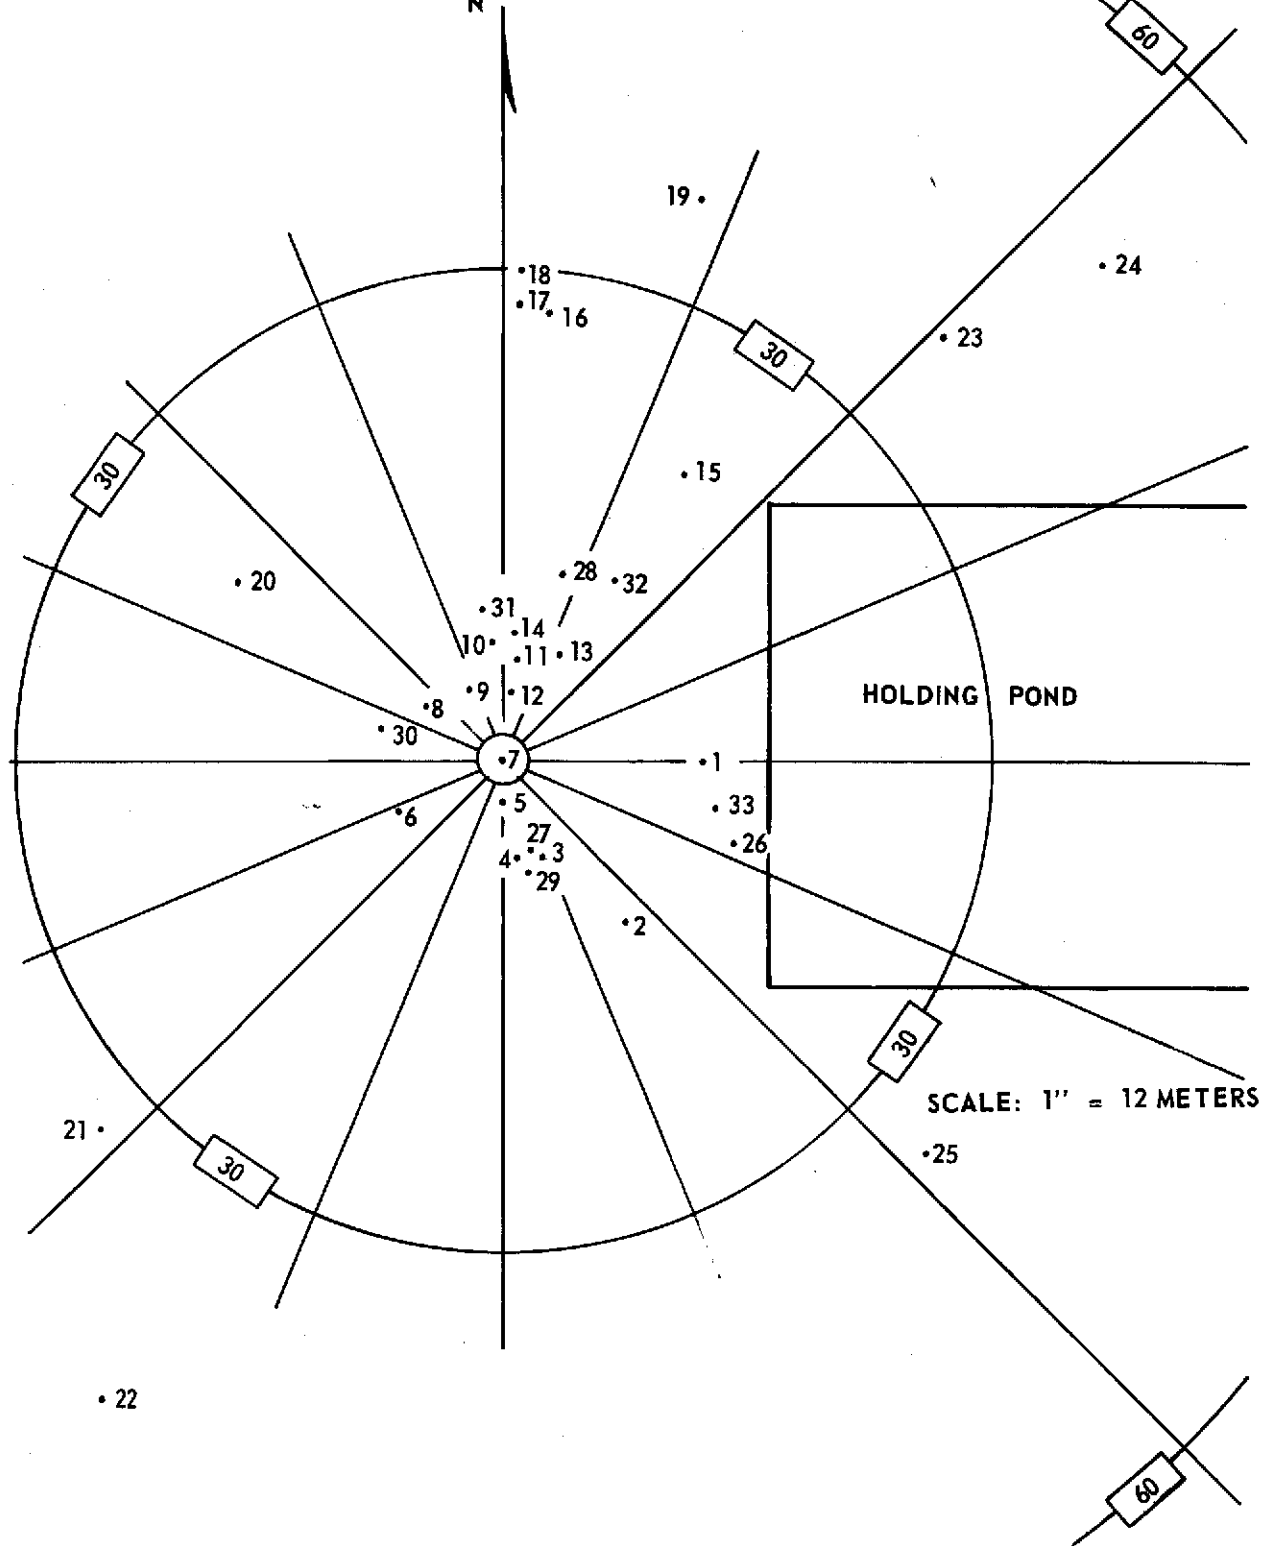
Figure 20. Map of Fragment Location
